## Pinkwood PKjoists® Minor Flange Cuts and Banding Damage

# TECHNICAL BULLETIN

TB06

January 2026

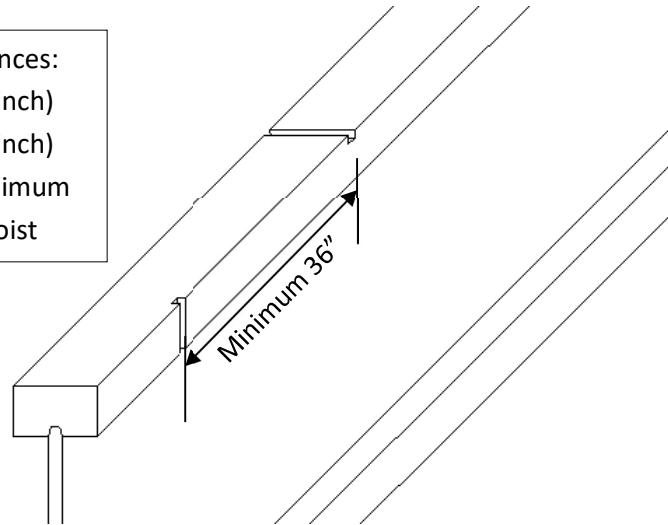
When handling, cutting and packaging PKjoists®, it is common for small cuts to be mistakenly made to the joist flanges. These cuts can be as the result of a chainsaw blade bump to the top of the joist pack or a skill-saw cut with the depth guard improperly set. While these small cuts are unsightly, they do not affect the performance of the joist provided they fall within the following limitations:

Maximum allowable distances:

- Depth =  $\frac{1}{4}$ " (0.25-inch)
- Width =  $\frac{1}{4}$ " (0.25-inch)
- Spacing = 36" Minimum
- Quantity = 2 per joist

***Note: If minor flange cuts or banding damage exceed those listed above, a review from a licensed design professional may be required.***

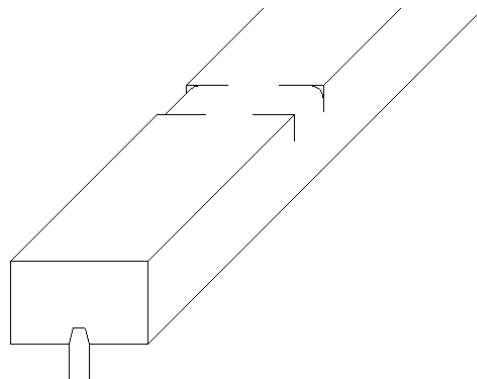
Crushing damage can occur when joist pack banding is cinched too tightly around the I-joist. This is particularly true when the joist has been exposed to wet weather conditions prior to or during the banding process. The appearance of banding marks and flange distortions, as seen below, does not affect the performance of the joist.
