## Pinkwood PKjoists® Top Flange Notch Repair for Plumbing

### Flange notch repair

**TECHNICAL BULLETIN**  
**TB10**

January 2026

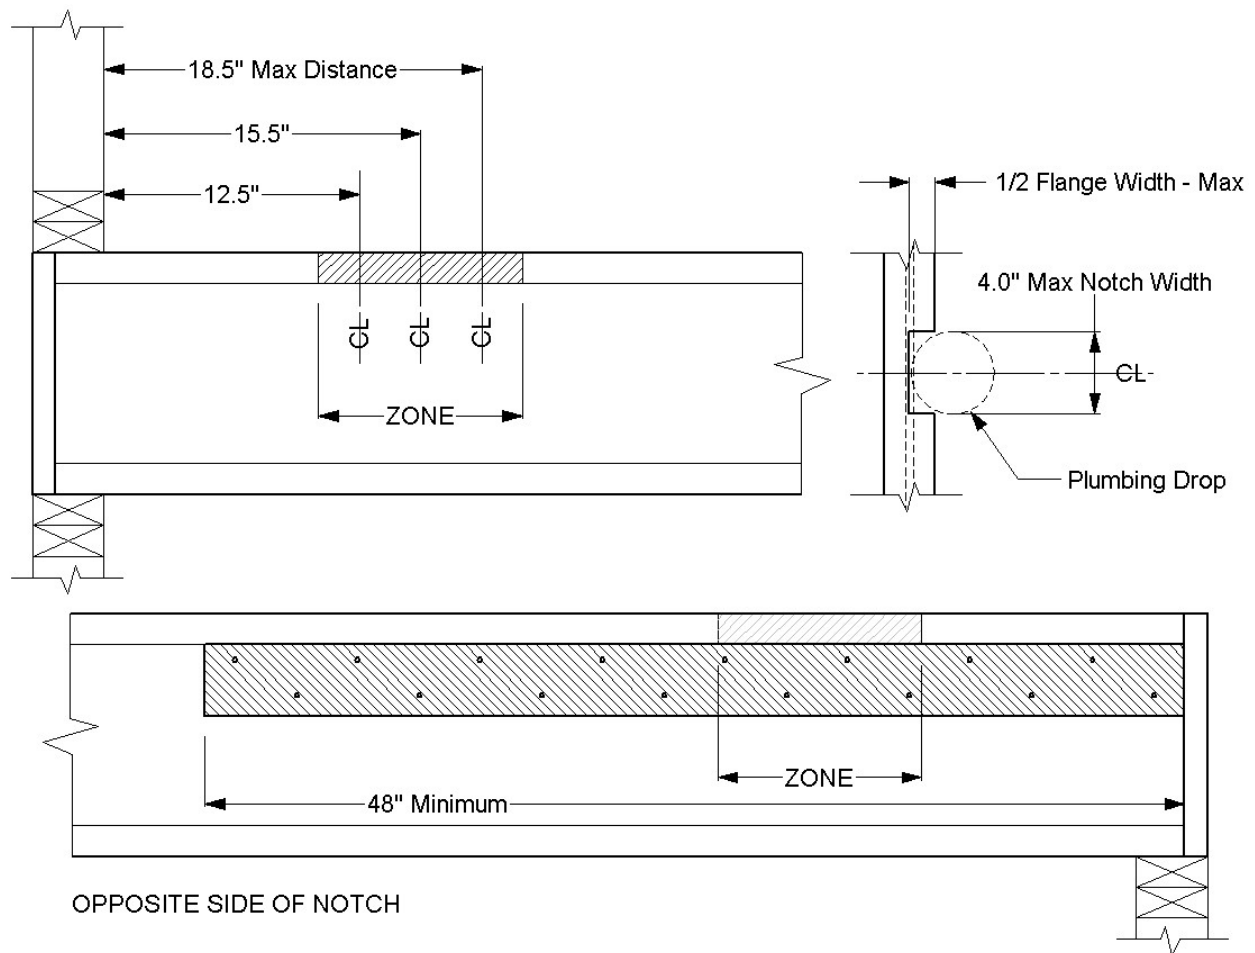
While It is common for drops to occur close to joist locations, when possible, shift the joist away from such drops to avoid inadvertent cutting with the joist top flange. (see **TB02 On-Center shift allowance for plumbing**) When this is not possible, or when the joist shift was missed during construction, top flange notches on uniformly loaded joists can be repaired in a standardized method provided the location, size and length of these notches are as indicted below.

1. Use minimum 2x4 #2 Grade or better.
2. Apply construction adhesive to entire contact surface of reinforcement.
3. Install reinforcement tight to the underside of the top flange opposite the side of the notch.
4. Attach with min 10d common, 2 rows, staggered and clinched @ 6" o.c. or #8 wood screws.
