## Pinkwood PKjoists® Standard Top Flange Notch Repair

## TECHNICAL BULLETIN

TB11

January 2026

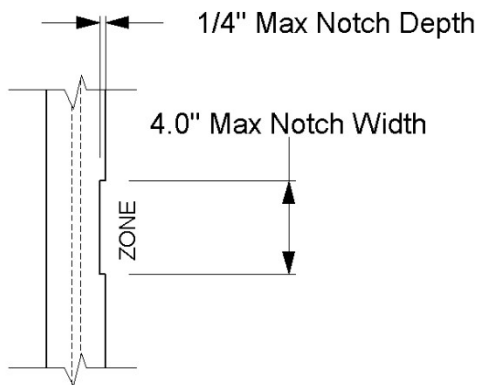
#### Notch Dimensions

While it is common for subfloor penetrations to occur close to joist locations, it is recommended, when possible, to shift the joist away from such penetration to avoid inadvertently cutting the joist top flange. (**see TB02 On-Center shift allowance for plumbing**) When this is not possible, or when the joist shift was missed during construction, minor top flange notches on uniformly loaded joists can be repaired in a standardized method provided the location, size and length of these notches are as indicted below.

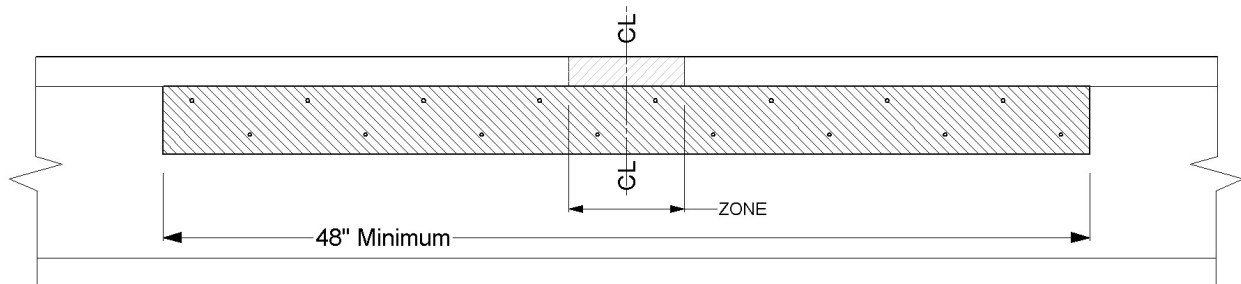
#### Repair Location

OPPOSITE SIDE OF NOTCH

1. Use minimum 2x4 #2 Grade or better.
2. Apply construction adhesive to entire contact surface of reinforcement.
3. Install reinforcement tight to the underside of the top flange opposite the side of the notch.
4. Attach with min 10d common, 2 rows, staggered and clinched @ 6" o.c. or #8 wood screws.
