## Pinkwood PKjoists® Web Repair with Services Remaining

### I-joist web repair for holes

**TECHNICAL BULLETIN**  
**TB15**

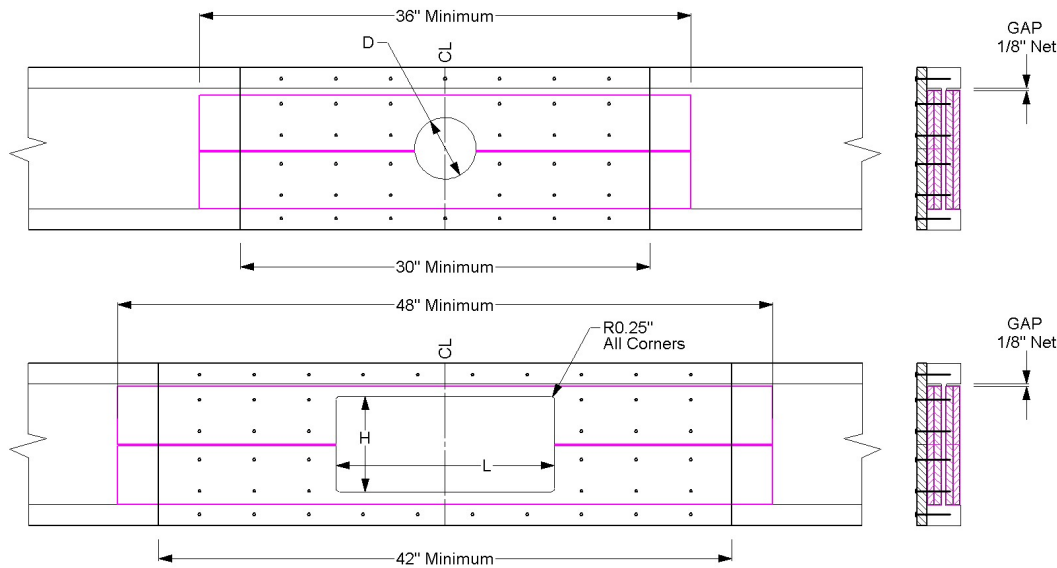
When holes are cut in the wrong location through the web of a PKjoist®, it is recommended to remove the service item and patch the hole per **TB12 "Standard Web Repair"**. When this is not practical and the penetrating item must remain as placed, the following detail can be used to restore the joist allowable shear with the following hole size and location restrictions.

1. Fill web with rated sheathing flush to outside of flanges, both sides, cut tightly around hole.
2. Apply construction adhesive to all contact surfaces of panel pieces.
3. Apply second layer of 23/32" rated panel, one side, cut tightly around hole.
4. Apply construction adhesive to entire backside and top edge of panel.
5. Secure to flanges and base layer with 8d nails x 2.5" long, 6 rows at 4" o.c.
