## Web hole shear restoration repair

# TECHNICAL BULLETIN

TB12

January 2026

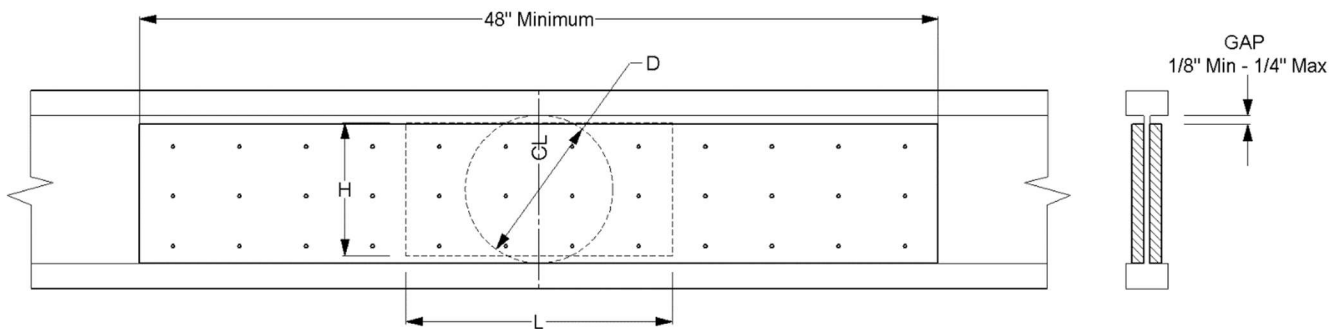
PKjoist® web penetrations for mechanical, plumbing and electrical services is quite common. Occasionally, however, a penetration can occur in the wrong place or too close to an adjacent web penetration. The provided detail restores the joists original web shear capacity provided that the joist is uniformly loaded, at least 24-inches from bearing, and the web penetration does not exceed the dimensions listed below.

Repair Detail Limitations

1. Use minimum 23/32" rated panel on both sides of joist.
2. Apply construction adhesive to entire contact surface of reinforcements.
3. Install reinforcement tight to the topside of the bottom flange centered over penetration.
4. Attach with min 8d common, 3 rows, clinched @ 4" o.c.
